Debris/Ice/TPS Assessment and Integrated Photographic Analysis of Shuttle Mission STS-71

**DEBRIS/ICE/TPS ASSESSMENT
AND
INTEGRATED PHOTOGRAPHIC ANALYSIS
OF
SHUTTLE MISSION STS-71**

27 June 1995

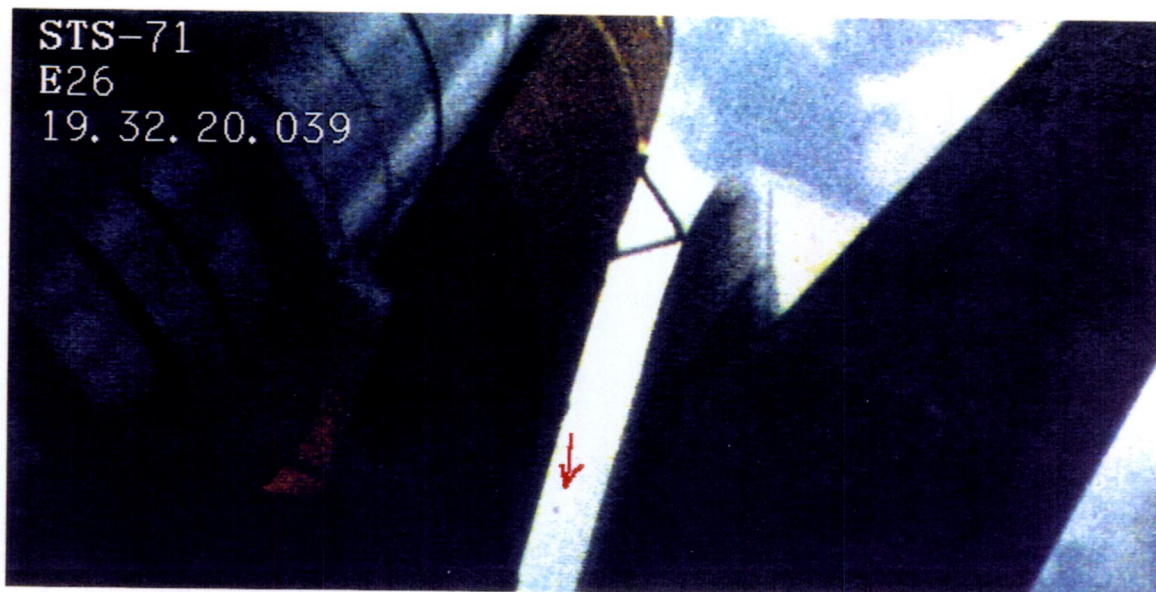
Figure 2.1.3.1 Debris at 1.1 Seconds MET

A small dark piece of debris was seen falling between the Orbiter and the ET at liftoff. The debris was first seen forward of the ET/Orbiter umbilicals. The debris was not seen to contact the launch vehicle. No follow-up action was requested.

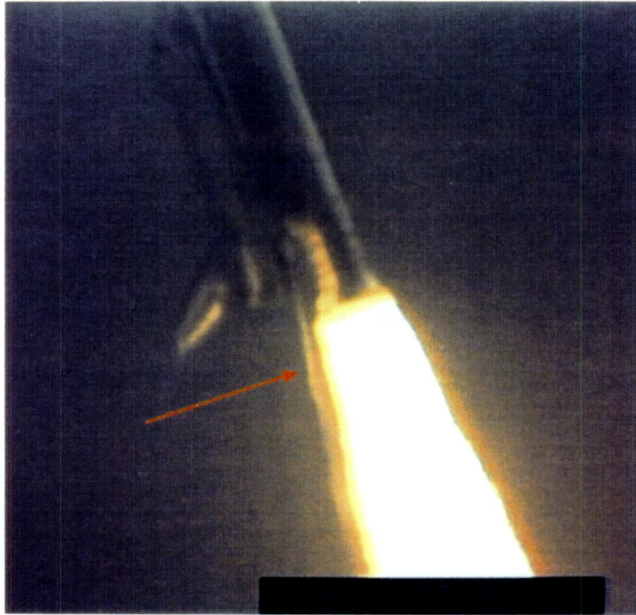
Figure 2.3.1 White Stream off Wing Tip

A white stream, possibly a contrail, was seen originating from near the Orbiter starboard wing tip at 17.3 seconds MET. No follow-up action was requested.

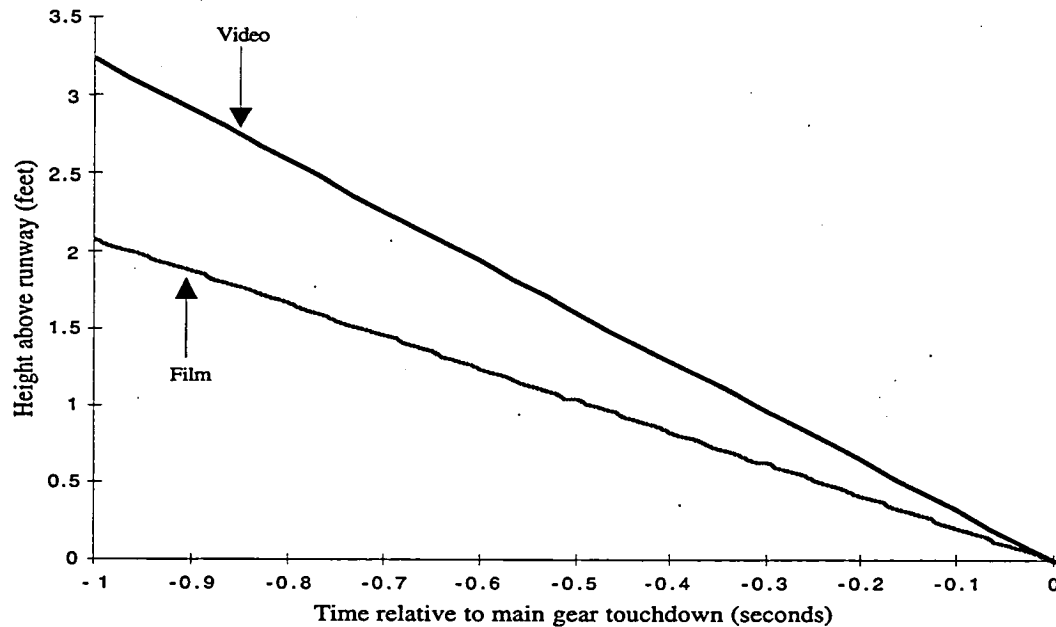
Figure 2.5.1 (A): Main Gear Sink Rate from Film (EL7) and Video (KTV33L) (Shown as Trend of Data Points)

The measured main gear and nose gear sink rate values were found to be below the maximum allowable values of 9.6 ft/sec for a 211,000 lb. vehicle and 6.0 ft/sec for a 240,000 lb. vehicle (the landing weight of the STS-71 Orbiter was reported to be 216,372 lbs.). The sink rate measurements for STS-71 are given in Table 2.5.1. In Figures 2.5.1 (A) and 2.5.2 (B), the trend of the measured data points for both film camera image data and video image data are illustrated.

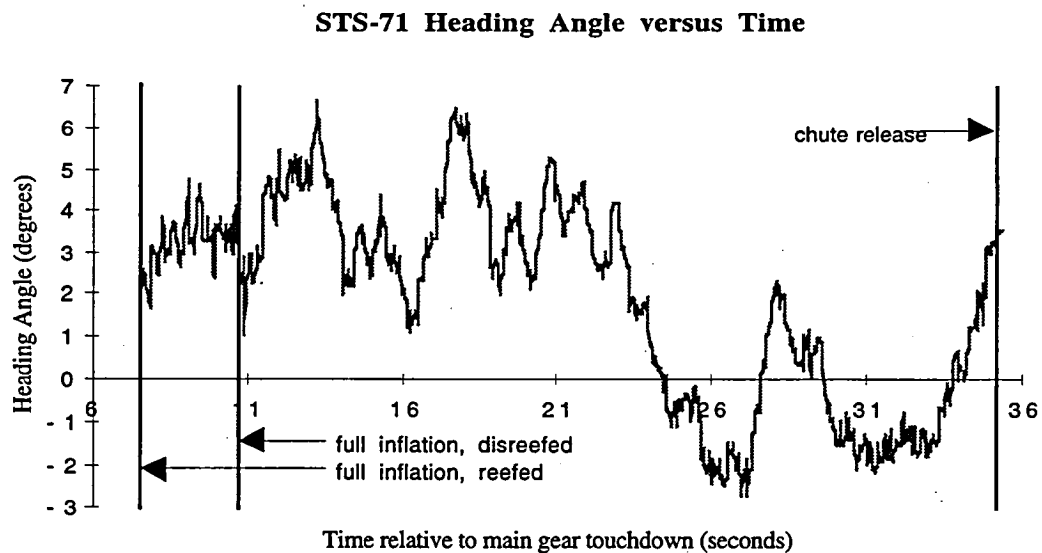
Figure 2.5.2 (A): Drag Chute Heading Angle versus Time

This analysis is used to support the improvement of the aerodynamic math models currently in use. Figure 2.5.2 (A) presents the measured heading angle versus time. Figure 2.5.2 (B) presents the measured riser angle versus time. The maximum measured horizontal chute deflection (heading angle) was approximately 6.7 degrees to the starboard side of the vehicle. The vertical chute deflection (riser angle) ranged from -9 to +0.7 degrees relative to the Orbiter coordinate system.

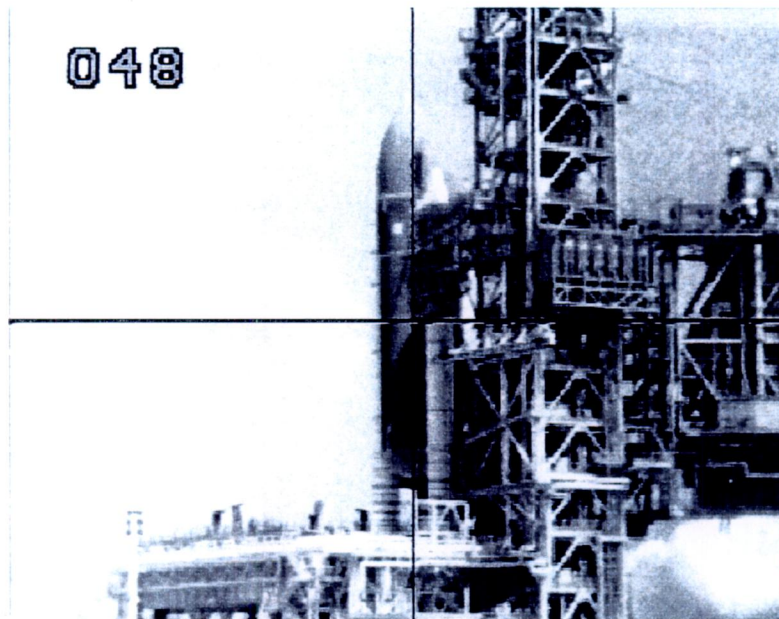
A flash of light was noted on the right SRB during booster ignition. Figure one is a video frame from camera OTV-048 showing the event.

Figure 1 Frame from video camera showing light flash on SRB

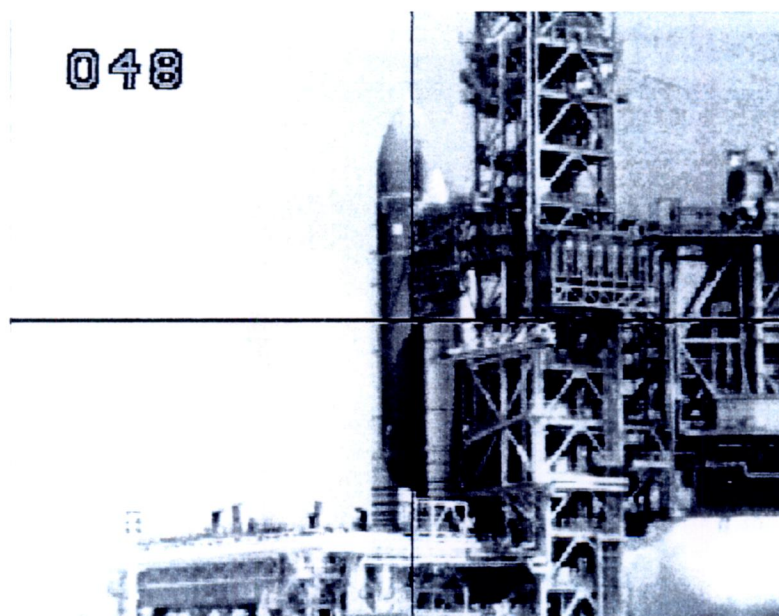
Figure two is a frame from camera OTV-048 prior to the event and is used for comparison.

Figure 2 Video frame prior to flash event

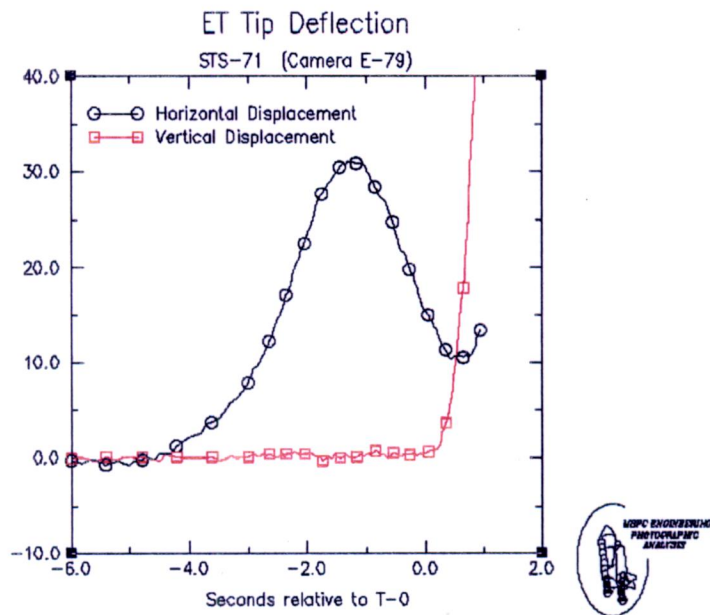
Figure 10 ET Tip Deflection

Maximum ET tip deflection for this mission was measured to be approximately 31 inches. Figure ten is a data plot showing the measured motion of the ET tip in both the horizontal and vertical directions. A positive horizontal displacement represents motion in the -Z direction. These data were derived from film camera E-79.
